BMW Z3 roadster and coupe Seatbelt Guide Repair Kit Instructions

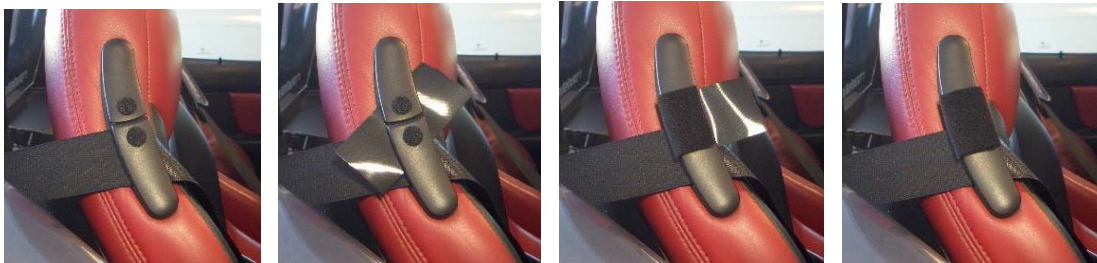
Fig. 1

Here is our repair solution. This simple to install device will not fix the broken seatbelt guide but it will make the seatbelt guide operable once again and prevent further damage to the leather. This repair kit contains two (2) VELCRO seatbelt repair pieces and four (4) adhesive VELCRO dots.

1. Place one of the adhesive dots on the upper portion of the seat belt guide and one on the lower portion as shown in Fig. 1.
2. Place the two-sided BLACK Velcro strip into the seatbelt guide as shown in Fig. 2, so that the hook side (shiny side) of the Velcro will attach to the adhesive dots.
3. Wrap the rear portion of the Velcro strap forward so it attaches to the Velcro dots as shown in Fig. 3.
4. Wrap the front portion of the Velcro strap over the rear portion as shown in Fig. 4.
